**CITY OF ROCKVILLE HISTORIC DISTRICT COMMISSION  
STAFF REPORT**

**April 17, 2003  
MEETING NO. 04-03**

**APPLICATION:** HDC03-0244

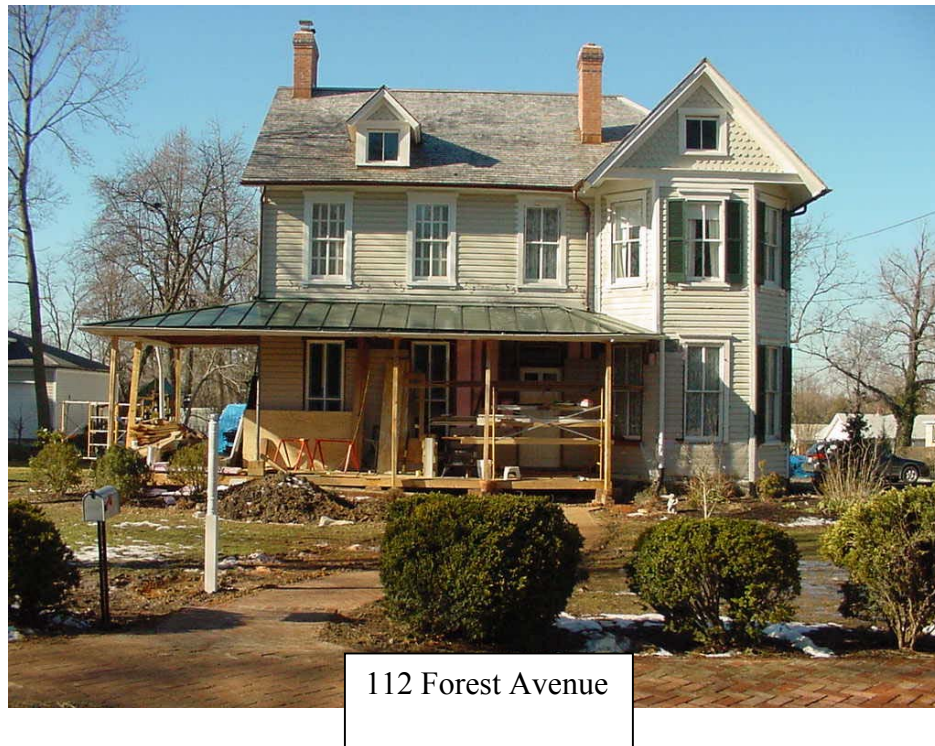
**REQUEST:** The Applicant requests a Certificate of Approval to restore and make the following modifications to the front porch roof:

1. Alter the slope of the hip adjacent to the bay to prevent water from flowing towards the bay as it currently does;
2. Raise the porch roof approximately five inches to correct subsidence on the front portion and make window trim more visible
3. Change the roof material from preformed steel to standing seam copper and replace existing over-sized aluminum gutters with 5-inch copper gutters to match the rest of the house.

Raising the porch roof will correct the subsidence in the front portion and will allow better visibility of the window trim. Modifying the bay-side hip will allow water to drain properly and prevent further damage to the bay. The roof material change from steel to standing seam copper and the gutter material from aluminum to copper are considered appropriate.

STAFF RECOMMENDATION: Staff recommends that the HDC approve application HDC03-0244 to restore and modify the design and materials of the front porch roof as described in the application.
